**Report on the November 2003
Ohio EPA Ground Water
Investigation at the
Miller Lumber Site
Pike County, Ohio**

By
David Hunt
OEPA-DDAGW-SEDO
February 13, 2004

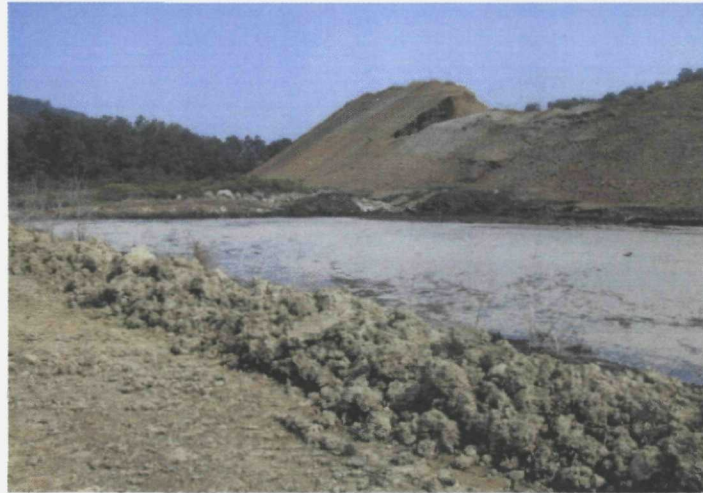
Figure 3 - Leachate pond and waste pile

In August 2003 the leachate holding pond was over topped and the embankment was breached resulting in the discharge of leachate over land for more than 500 feet to Kincaid Creek.

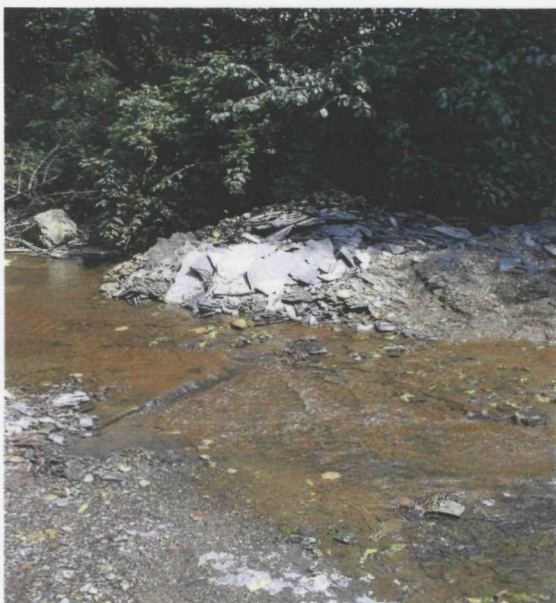
There are sink holes in the area near the Miller Lumber site. During the leachate release from the holding pond in August 2003, a sink hole was discovered within the stream bed which redirected stream flow into the subsurface. Fred Miller, owner of Miller Lumber operations, informed OEPA that Kincaid Creek was flowing black and that by his estimate 99% of the stream flow was entering the sink hole at that time. Mr. Miller also stated that the black water was from his site, and the result of the breach of the holding pond. The sink hole in the creek was filled in by Mr. Miller using stream sediment and rock rubble (Figure 4) in an attempt to reduce stream/leachate flow into the opening so Kincaid Spring would not be impacted.

Figure 4 - Filled in collapse. Photo also shows jointing in the creek bed.

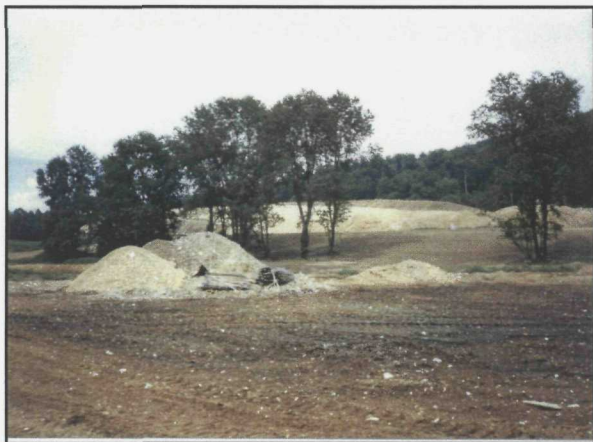
Figure 6 - Trees next to pond in 1996.

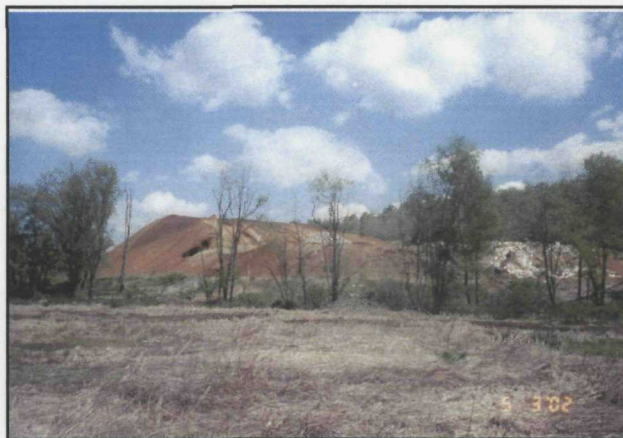
- the leachate collection trenches around the perimeter of the pile are unlined;
- dead trees hydraulically down gradient of the leachate pond which would indicate that a release is occurring and it is toxic to the trees;

Figure 7 - Trees next to pond in May 2002

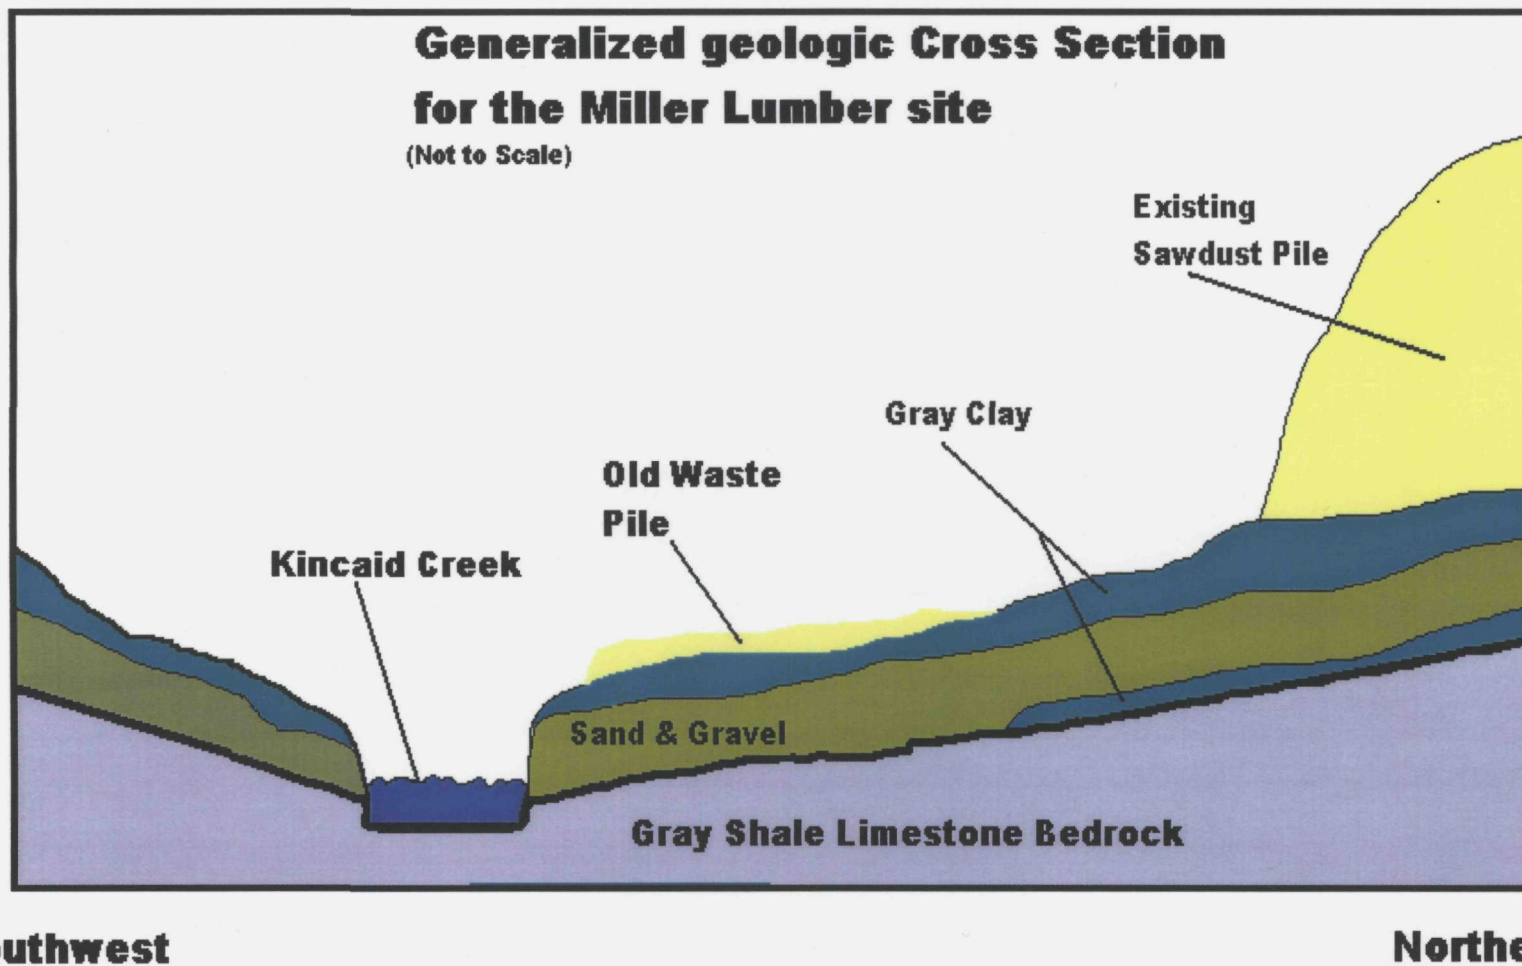
Figure 9 provides a generalized cross section for the Miller Lumber site. In general, there is a 10 to 15 feet thick layer of alluvial deposits consisting of clays, silts and sand and gravel underlain with bedrock consisting of a weathered blue-gray shale layer. At the two logged locations, six inches to one foot of sawdust was encountered. Several weeks prior to this investigation a hand auger was used by DDAGW and DSIWM staff to estimate the thickness of the sawdust within the old waste pile area. It was found that eighteen inches to one foot of sawdust was common. Based on the hand auger work and the geoprobe investigation it was found that beneath the sawdust veneer there is a gray to brown clay that is two to five feet in thickness. Beneath the clay layer was a five to six feet thick sand and gravel layer. Most of the gravel pieces were a half inch to one inch in size. The geoprobe had little difficulty driving the steel rods through the coarse gravel layer. Beneath the sand and gravel layer a weathered blue-gray shale was encountered, which is probably the same shale layer that outcrops within Kincaid Creek. Of the eleven borings, eight of them encountered bedrock at nine to twelve feet below ground surface. At GP-3 and GP-8 the geoprobe was able to advance the steel rods to 20 feet and 28 feet, respectively.

Figure 9 - Generalized cross section based on the geoprobe investigation.

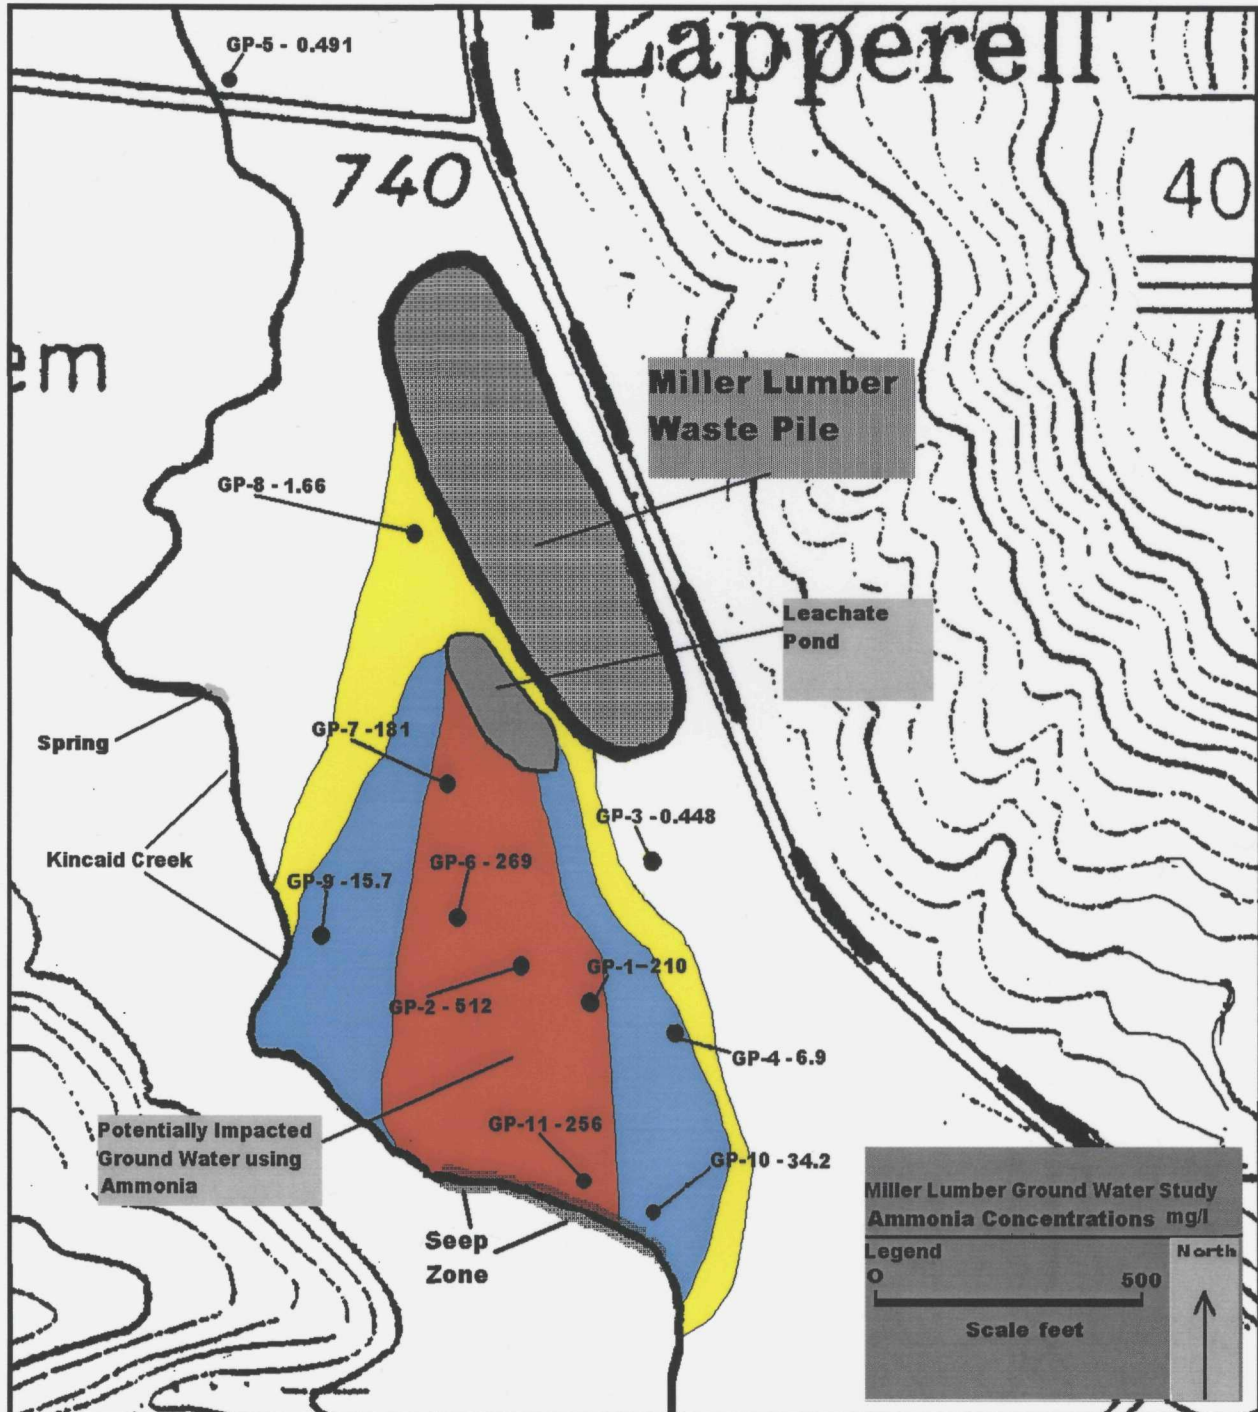
Ammonia is the best indicator of the waste pile leachate. GP-5 had an ammonia concentration of 0.491 mg/l. The average ammonia level for the downgradient geoprobe locations was 148 mg/l. The range in concentration within the plume was 6.89 mg/l to 512 mg/l. The background conductivity was 278 umhos/cm, whereas the average down gradient conductivity was found to be 2287 umhos/cm. The conductivity range encountered in the plume was 750 uhmos/cm to 5300 uhmos/cm. TDS had a background value of 166 mg/l. The average downgradient TDS concentration encountered in the other ten locations was 910 mg/l, while the TDS within the plume ranged between 414 mg/l to 1690 mg/l. The background COD value was 64 mg/l at GP-5 and the downgradient locations showed an average COD value of 441 mg/l. The COD range encountered was 72 mg/l to 1250 mg/l. As seen in table 2, locations GP-1, GP-2, GP-6, GP-7, and GP-11 show the greatest impact from the site. Clearly, based on the sampling data the Miller Lumber waste pile/holding pond complex has impacted ground water.

The concentrations of the water quality parameters were plotted on base maps of the site to evaluate the ground water contaminant plume distribution (Figures 10-15). There is a well defined area of ground water contamination to the southwest of the waste pile. Looking at figure 10, there is a highly concentrated area of ammonia contamination present at the site. The contamination appears to extend from the pond through the field of the old waste pile and to Kincaid Creek. The area of impact, or the plume of contamination, appears to be approximately 400 feet wide and 750 feet long. An interesting finding is that the zone of contamination seems to extend to the 200 feet long area of seeps along Kincaid Creek. The concentration map for TDS, COD, and conductivity show a similar geometry and extent. The nitrate-nitrite data and corresponding map show another interesting finding. Where the ammonia levels are very high (e.g. above 200 mg/l) the nitrite-nitrate is very low. This occurs in the interior of the plume. Where there is ammonia contamination, but the levels are less than 200 mg/l, the nitrate-nitrite is elevated. As shown in Figure 14 the nitrate-nitrite levels are high on the periphery of the plume where the ammonia is being oxidized from NH_3 to NO_2/NO_3 . In the interior of the plume, most of the available oxygen has been consumed by the oxidation of NH_3 and the constant release of ammonia to ground water gives rise to the high ammonia levels without NO_2/NO_3 .

Figure 10 - Ammonia concentrations from the November 2003 OEPA Ground Water Investigation

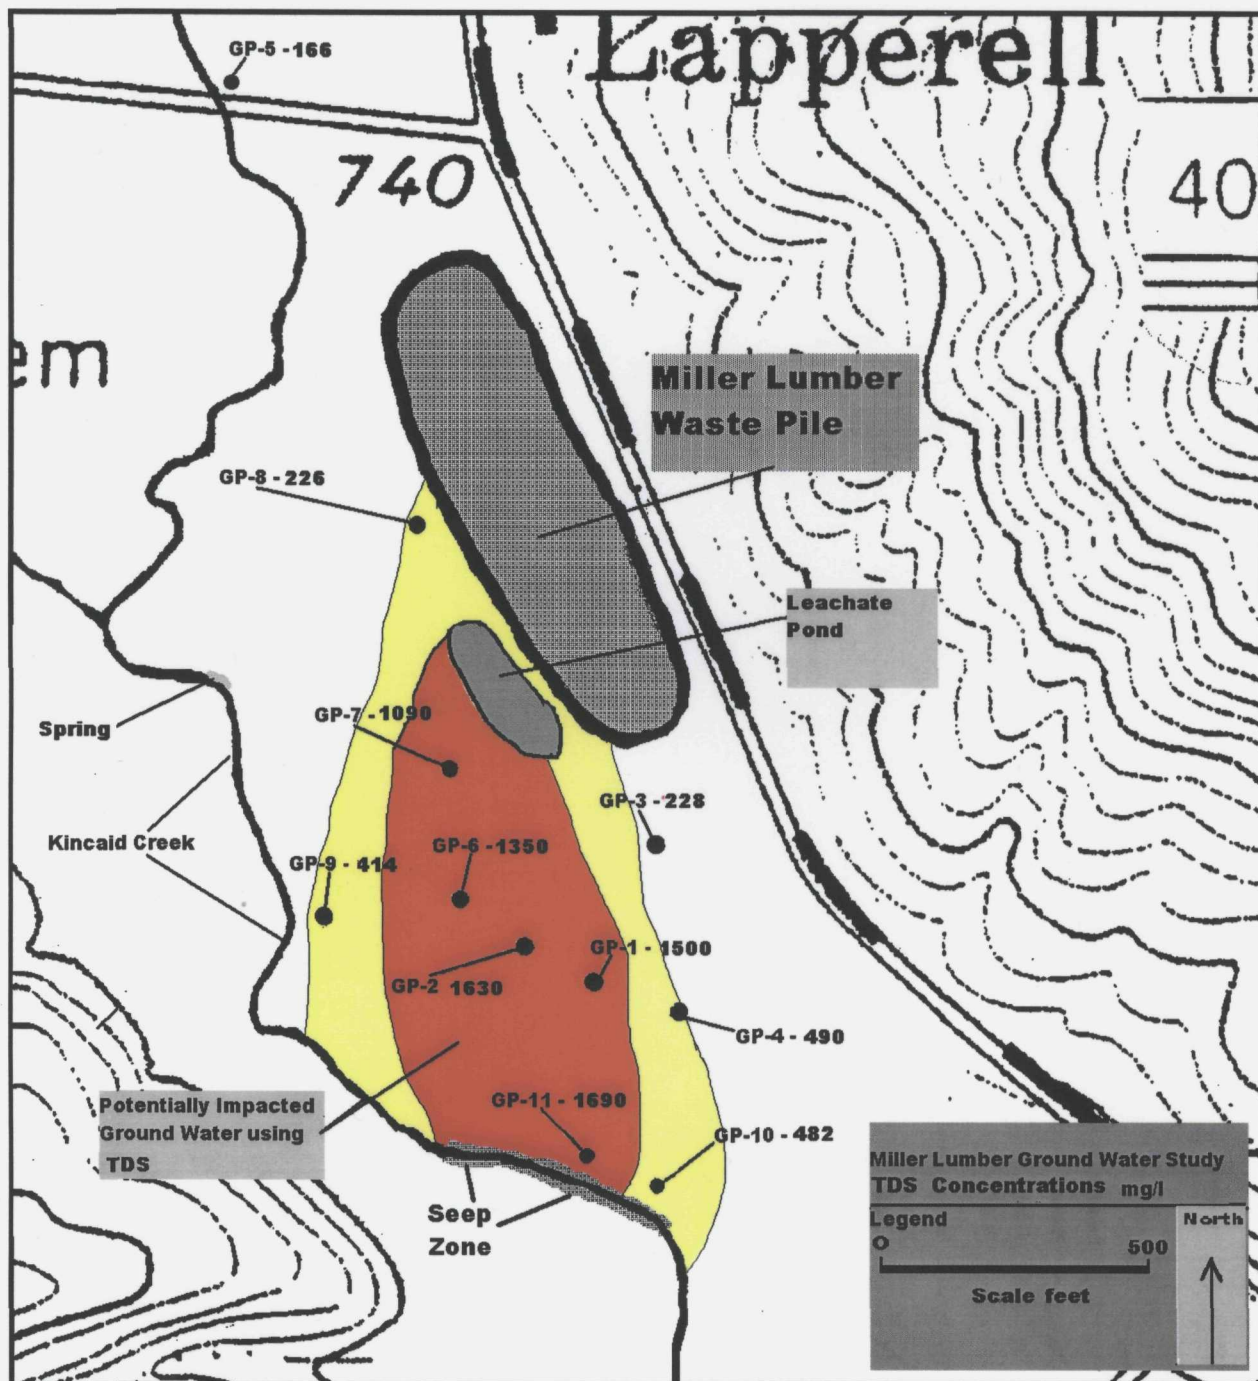
Figure 11 - TDS concentrations from the November 2003 OEPA Ground Water Investigation

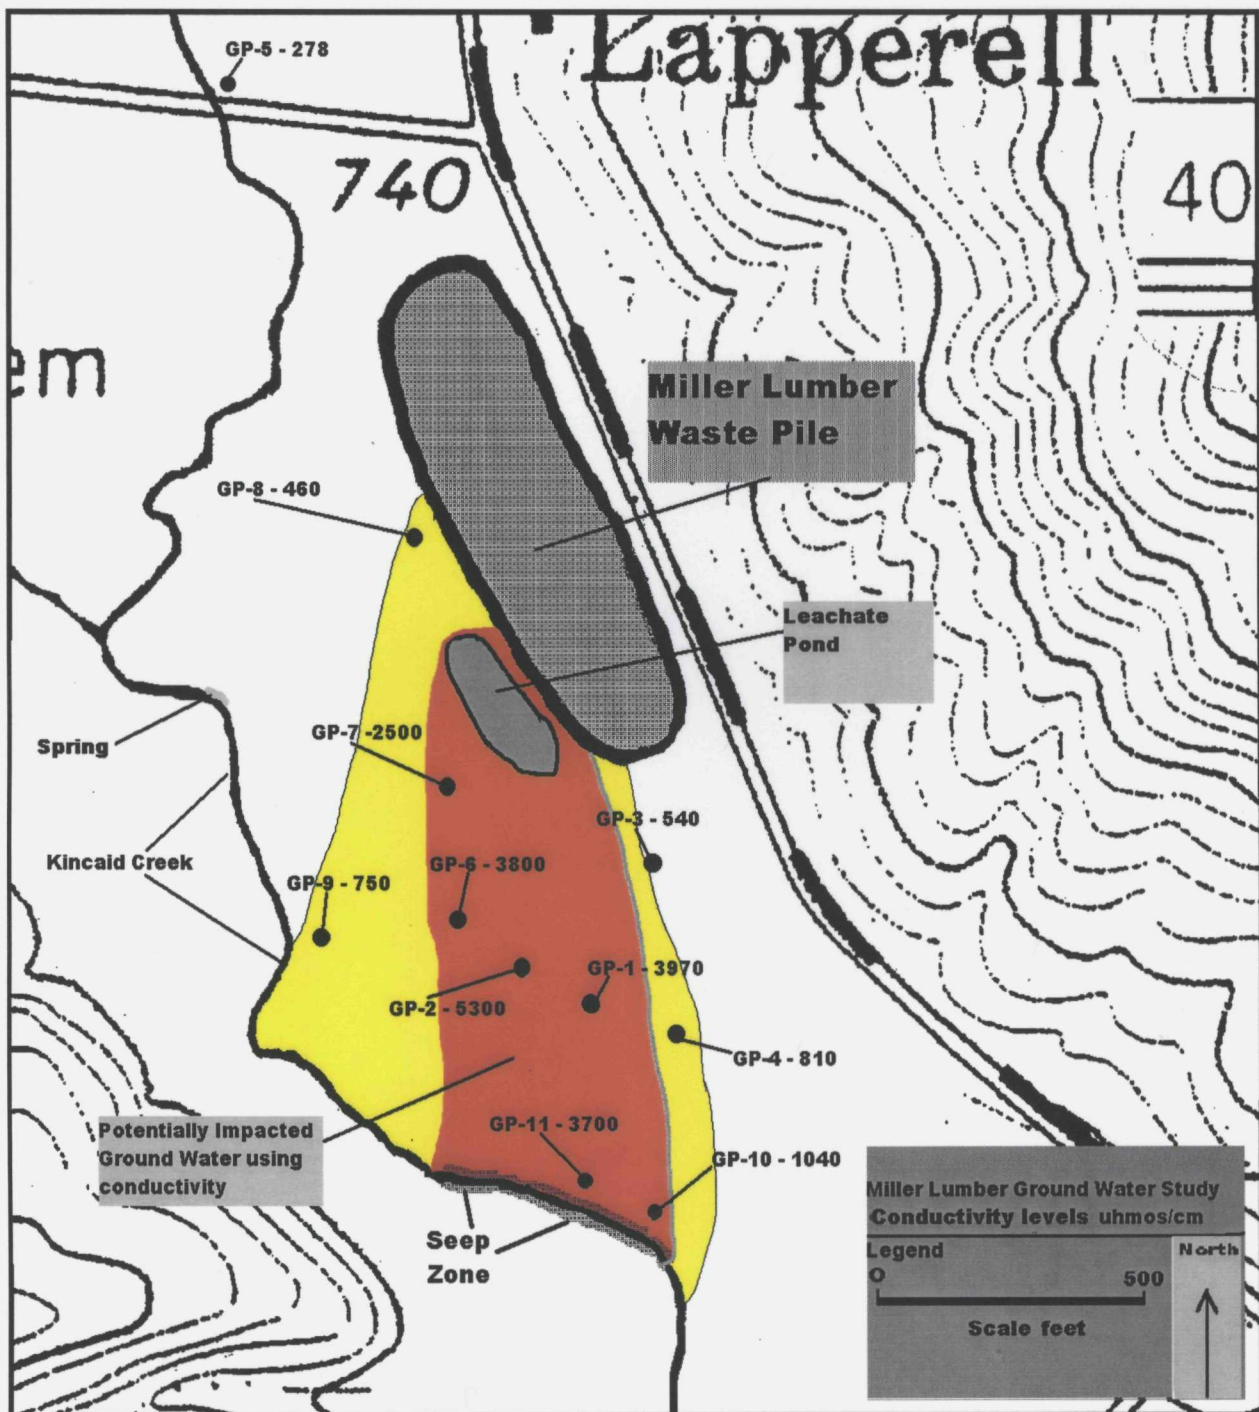
Figure 12 - Conductivity levels from the November 2003 ground water investigation.

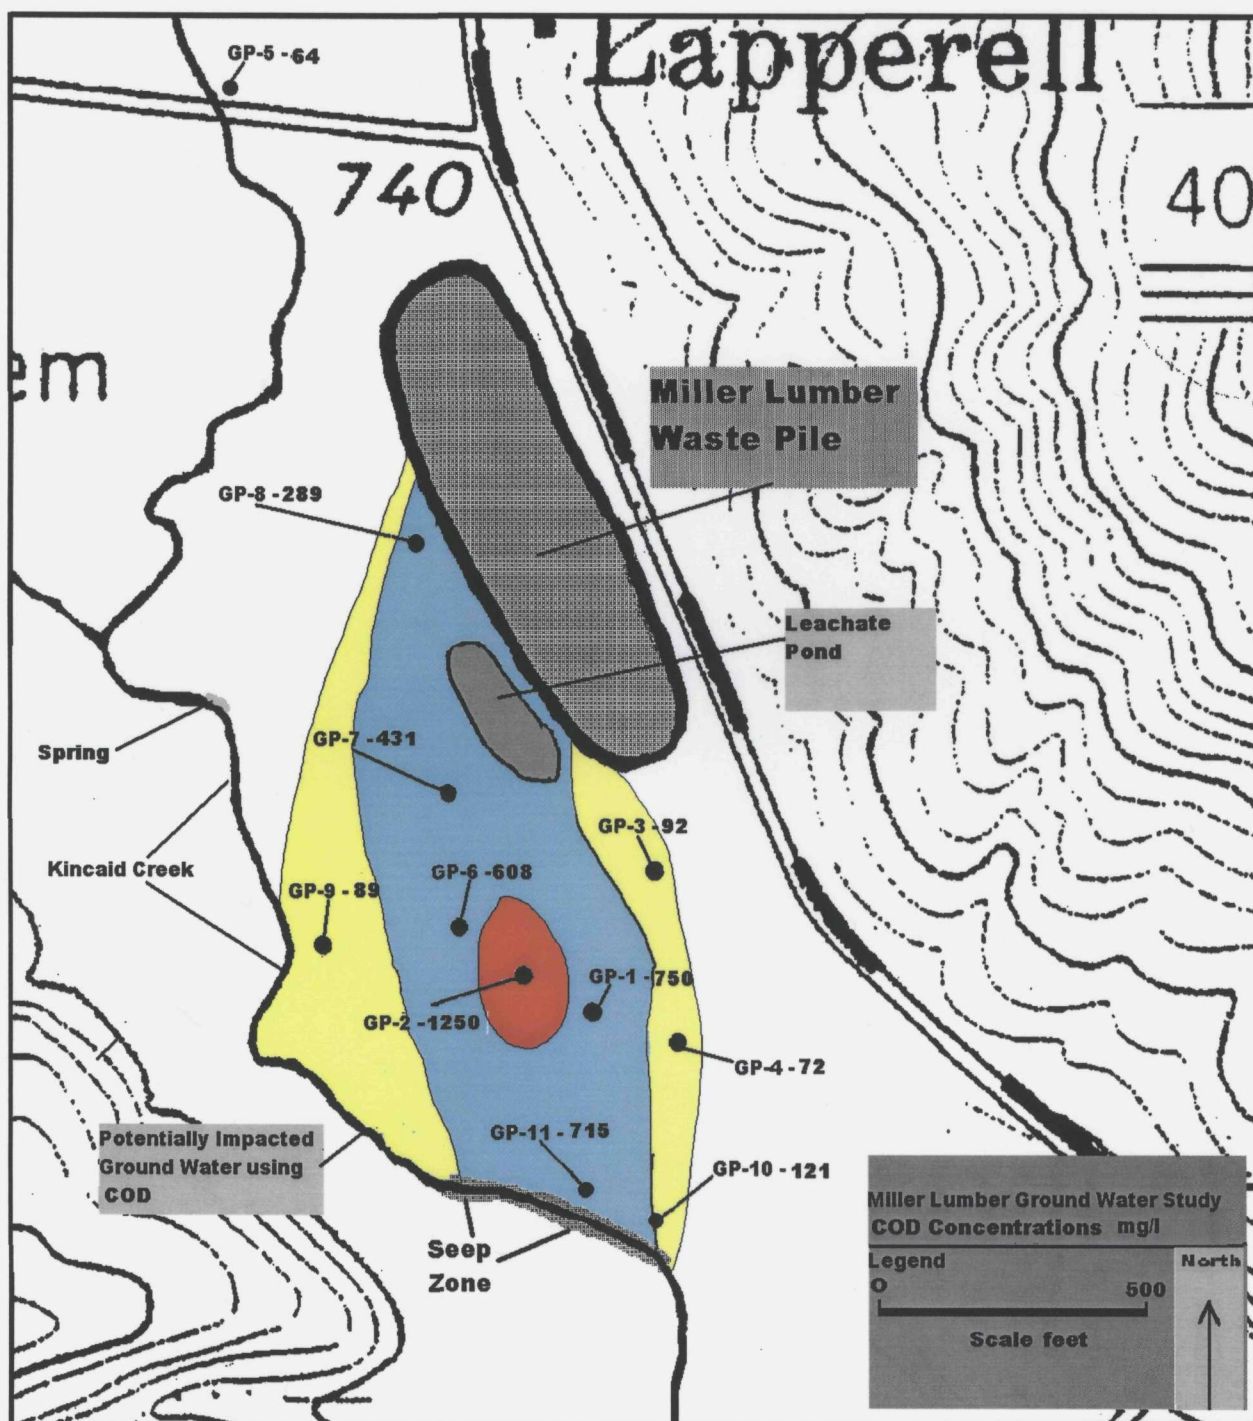
Figure 13 - COD concentrations from the November 2003 OEPA Ground Water Investigation

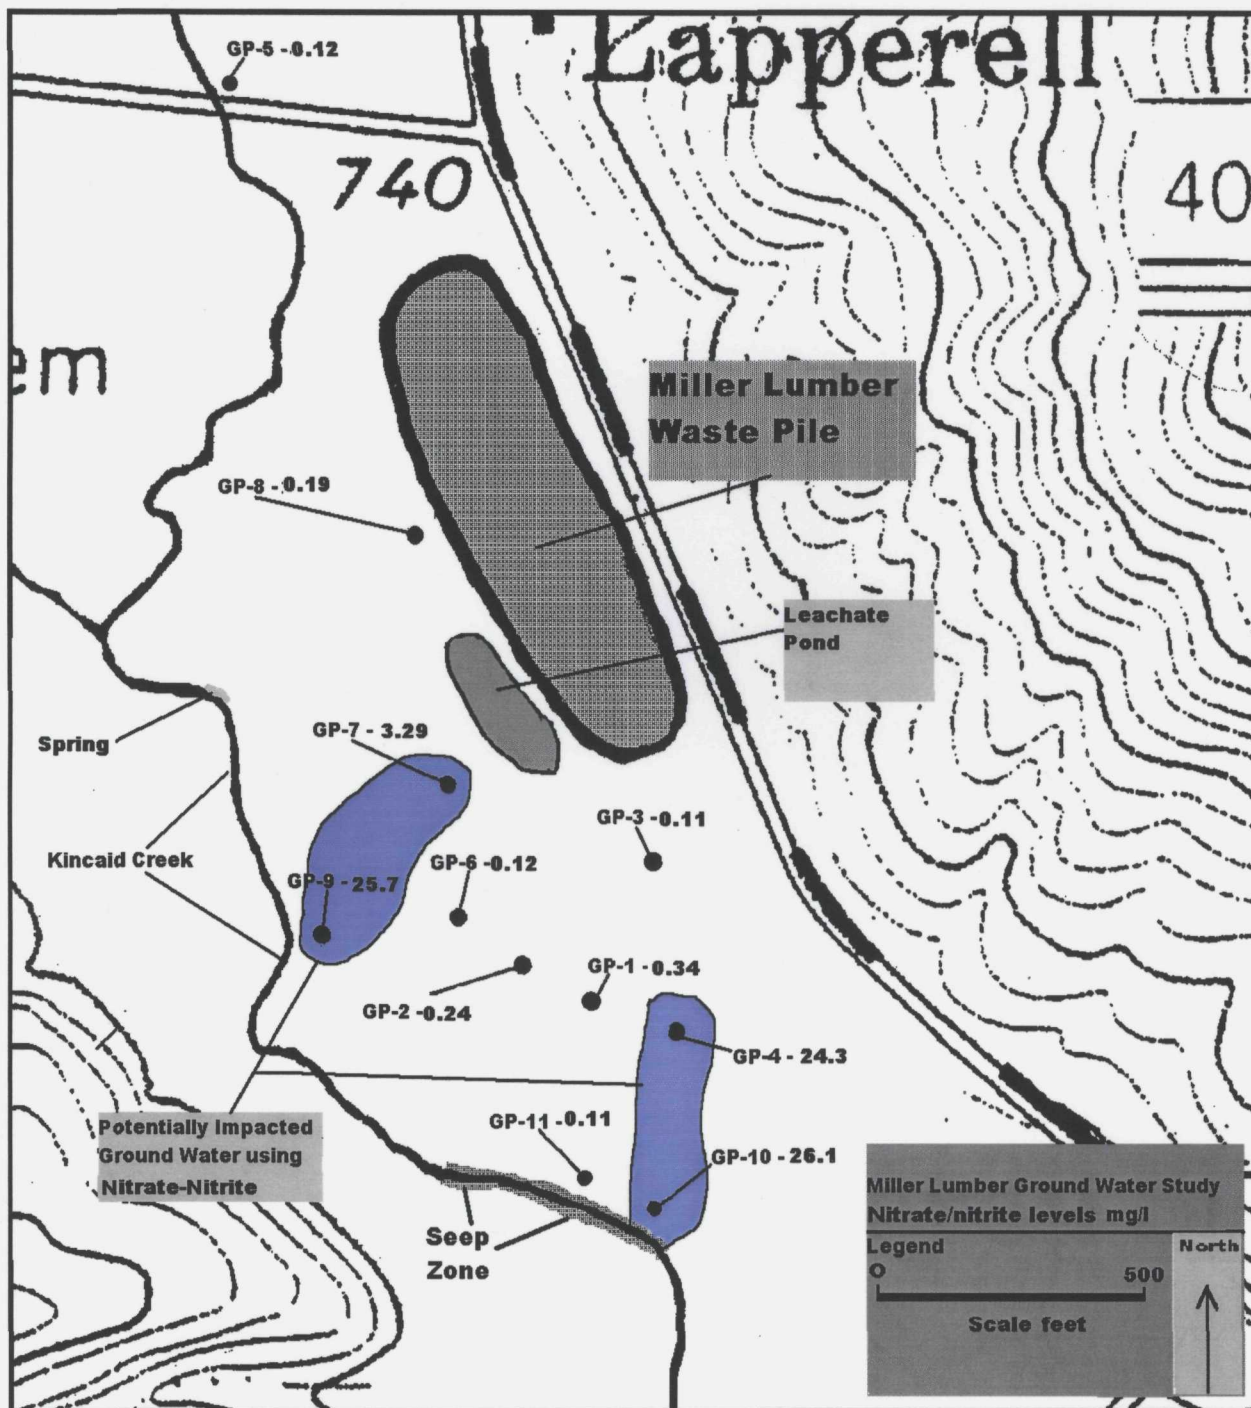
Figure 14 - Nitrate/Nitrite concentrations from the November 2003 OEPA ground water investigation.

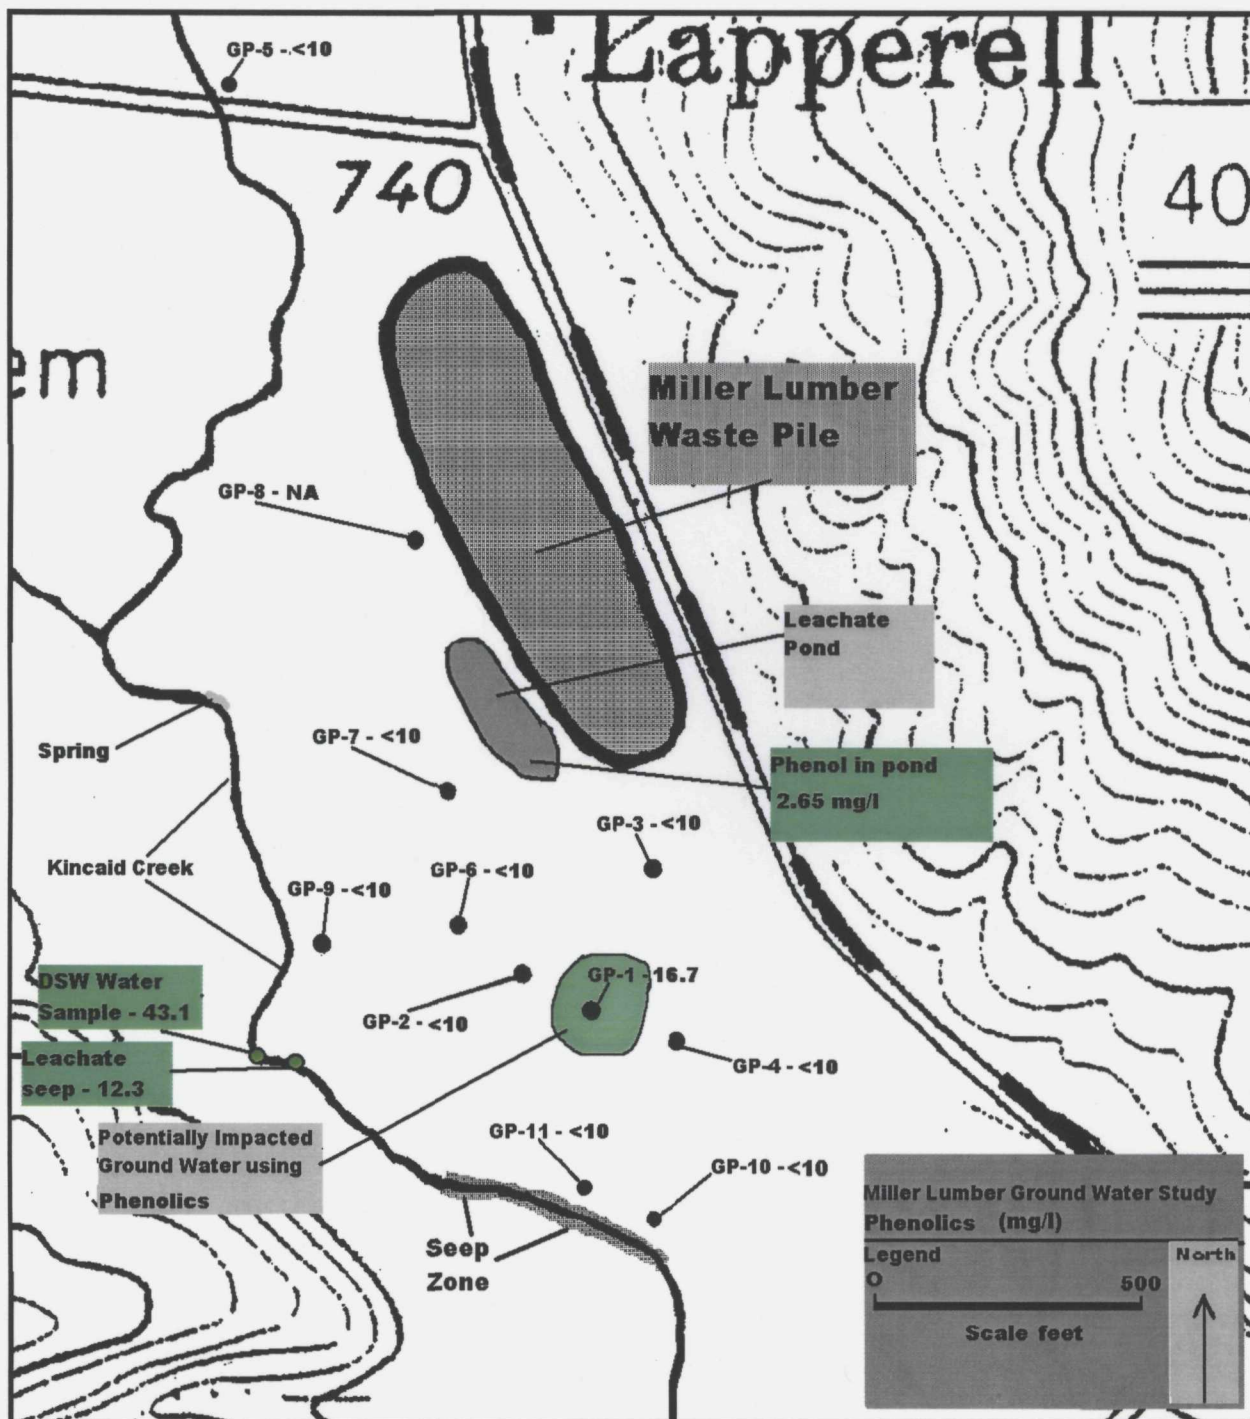
Figure 15 shows the results from the phenolics analysis. The results show that phenolics was found in one of the ten geoprobe samples collected (GP-8 did not have a phenolics sample due to low volume of water). The leachate was sampled by the OEPA-Division of Hazardous Waste Management (DHWM) in 2003 to determine if it was a hazardous substance. Only phenol was sampled and the result was 2.65 mg/l. The phenolics analysis that was performed on the ground water and the surface water samples demonstrate phenolics occur at the site but the results do not show a well defined area of impact. Figure 16 shows the location of seep sample collected by OEPA-DDAGW for VOCs. The concentration of the three VOCs detected are also plotted on the map. Future investigation work should include sampling for VOCs.

Figure 15 - Total Phenolics concentration detected in ground water from the November 2003 investigation. Also plotted on the map is Total Phenolics from DSW sampling and Phenol from a DHWM 2003 sampling of leachate.

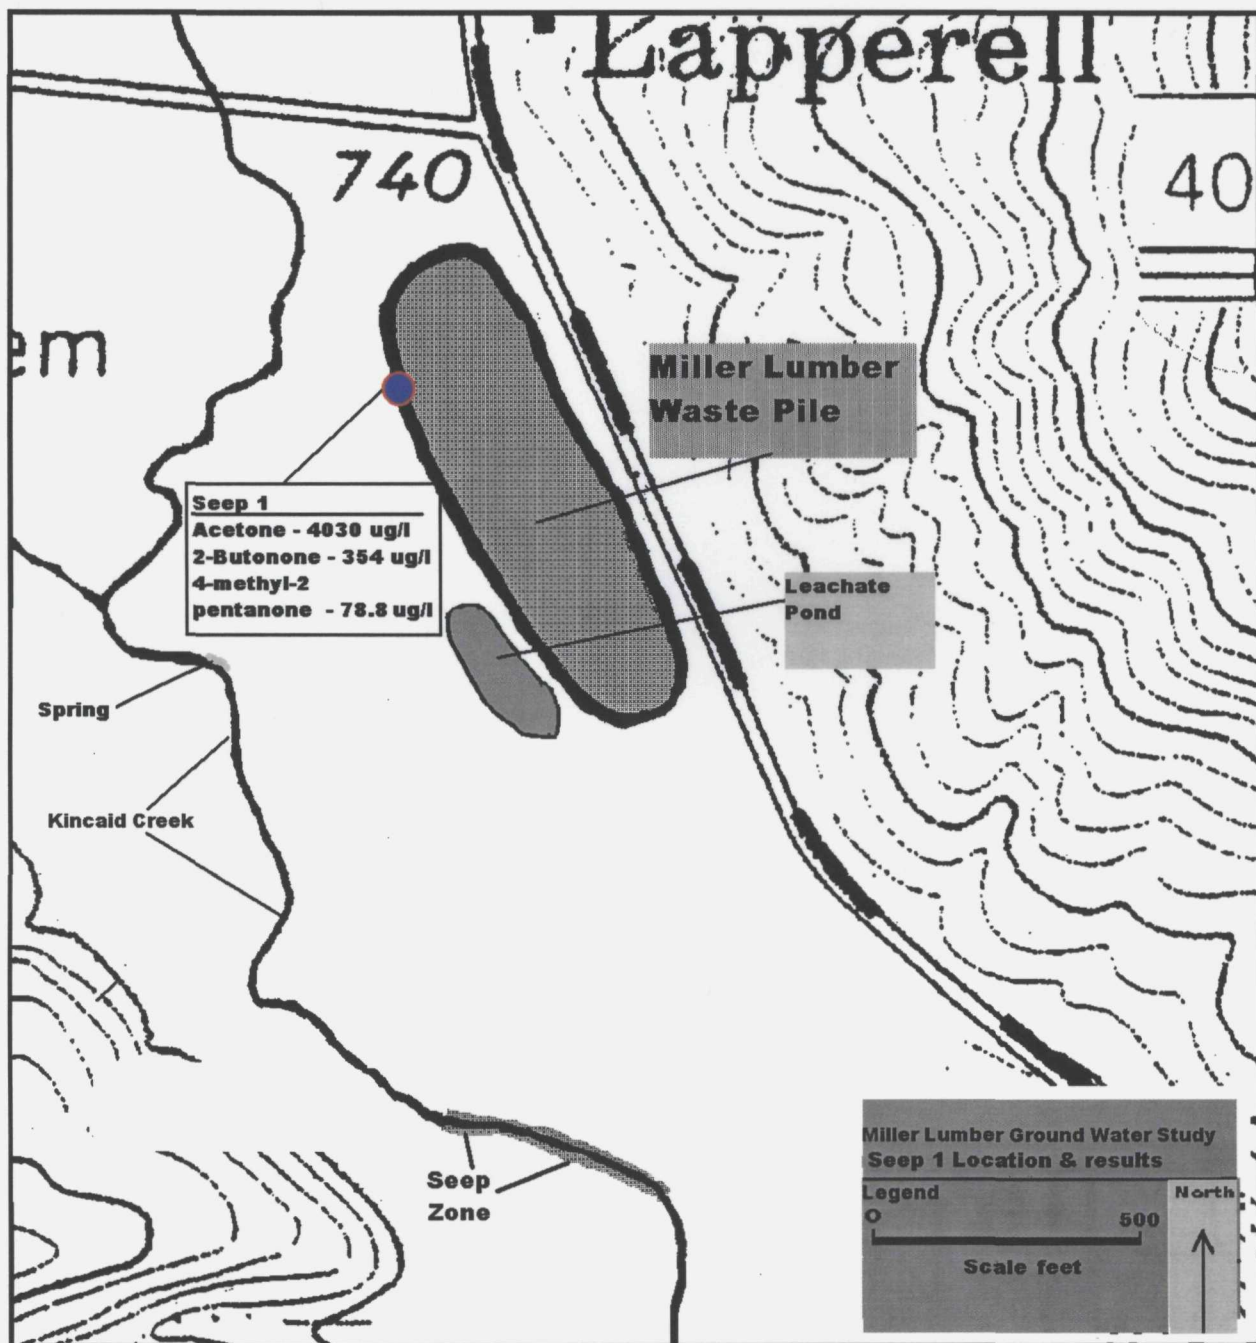
Figure 16 - Location and VOC results of the Seep 1 sampling location.

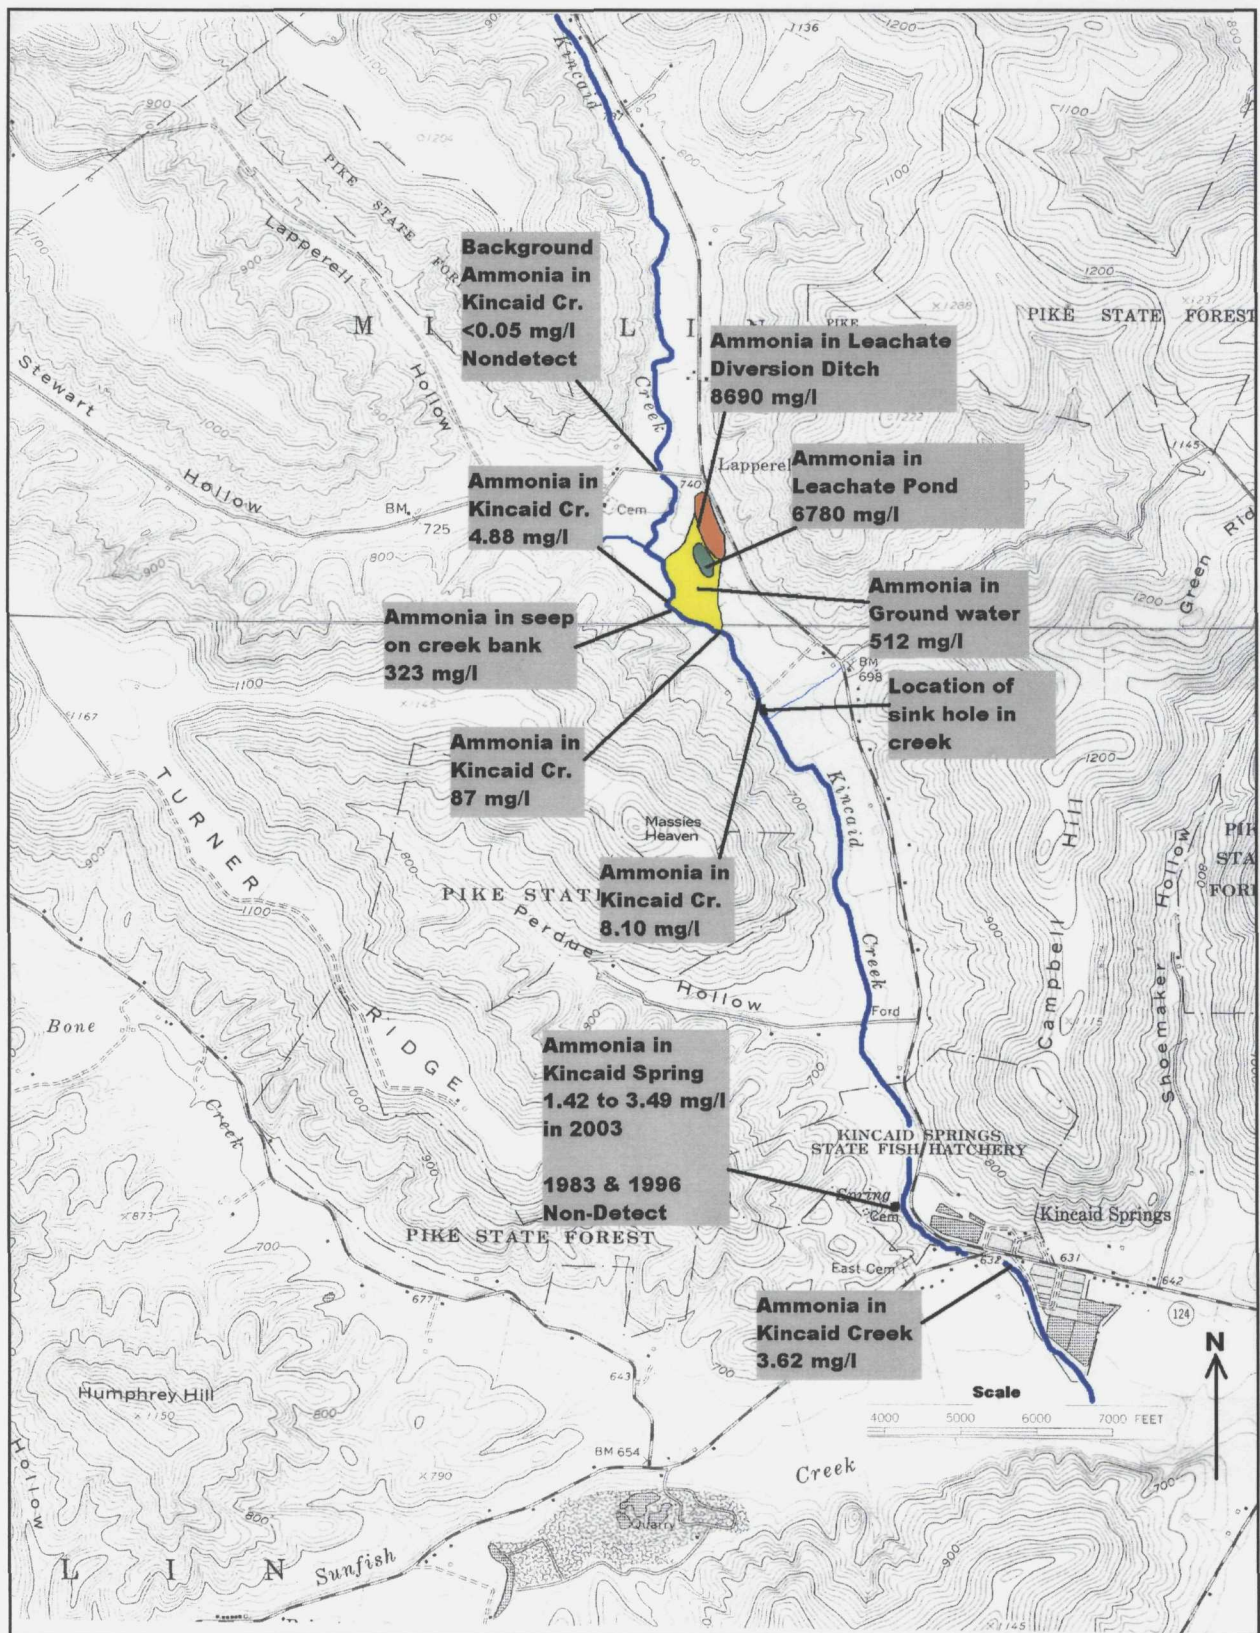
Figure 17 shows the ammonia results of the surface water sampling events, leachate sampling and from sampling Kincaid Spring. The surface water data is from a DSW study conducted in August/September 2003. Background sampling on Kincaid Creek upstream of the Miller Lumber site show ammonia levels to be non detect or below 0.05 mg/l. However, the chronic discharge of contaminated ground water via multiple seeps along Kincaid Creek south of the pile combined with leachate overflows from the pond and runoff from the old waste pile footprint has impacted the water quality of Kincaid Creek. Ammonia levels increase from non-detect up stream of the site to 4.88 mg/l to 87 mg/l within a 2500 feet length of Kincaid Creek. Concentrations of ammonia in the Kincaid Spring have ranged between 1.42 to 3.49 mg/l in 2003. In 1996, when DSW sampled the spring, the ammonia was nondetect.

Figure 17 - Ammonia data from the November 2003 ground water study and surface water data from DSW sampling events in 2003.
